# MINNESOTA STRUCTURE INVENTORY REPORT

Bridge ID: 9030

I 535 over ST LOUIS R; RR,STREET

Date: 05/13/2025

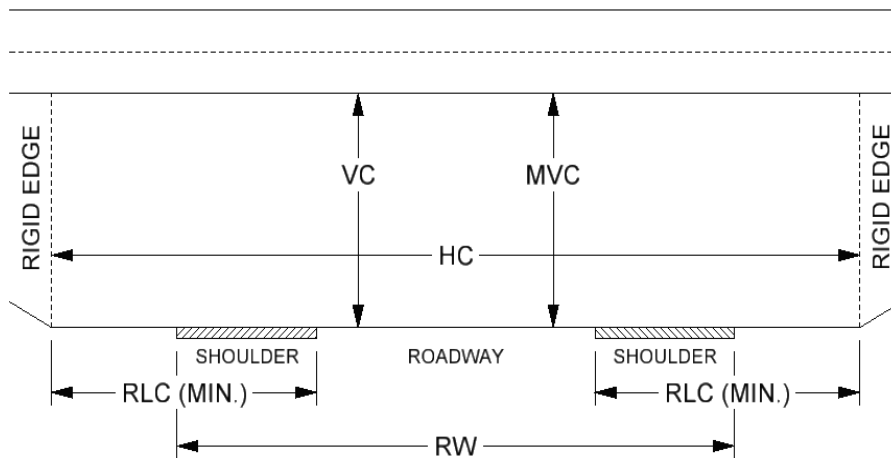
UNDIVIDED HIGHWAY  
2 WAY TRAFFIC

+ FEATURES +			+ DIMENSIONS +			
Item Description	NBI (if appl)	Value	Item Description	Diagram Abbrev.	Values	
					NB-EB	SB-WB *
Road Name		PINE STREET	Roadway Width	RW	38.0 ft	
LRS Functional Class	26	7 - LOCAL	Vertical Clearance	VC	70.8 ft	
ADT (YEAR)	29 (& 30)	3,000 (1975)	Max. Vert. Clear	MVC	70.8 ft	
HCA DT	109		Horizontal Clear	HC	127.0 ft	
National Highway System	104	N	Lateral Clr. - Lt	LLC	63.0 ft	
Route Sys/Nbr (LRS)		M 690	Lateral Clr. - Rt	RLC	23.0 ft	
LRS Mile Point		0.030	Median Width	MW	NA	
Reference Post		000+00.021	* Entered only if this record is for a divided roadway			
Detour Length	19	8 mi.				
Lanes	28B	2 Lanes UNDER Bridge				
Control Section (TH Only)						
Function	5C	MAINLINE				
Type	102	2 WAY TRAF				
Bridge Match ID	5A	3				
Roadway Key		B-UNDER (2ND)

RIGID EDGE IS A TOE OF SLOPE STEEPER THAN 1 TO 3 OR A FIXED OBJECT SUCH AS GUARDRAIL, PIER STRUT OR OTHER BARRIER.

RLC (RIGHT LATERAL CLEARANCE) IS THE MEASUREMENT FROM THE OUTSIDE EDGE OF THE ROADWAY TO THE RIGID EDGE. RIGHT IS DETERMINED WHEN FACING THE DIRECTION OF TRAVEL. RLC IS THE MINIMUM DIMENSION AFTER MEASURING IN BOTH DIRECTIONS.

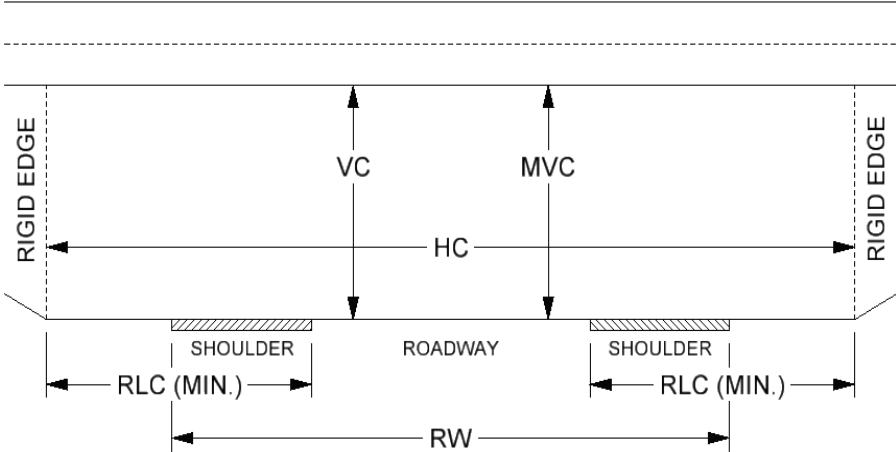
UNDIVIDED HIGHWAY  
2 WAY TRAFFIC

+ FEATURES +			+ DIMENSIONS +			
Item Description	NBI (if appl)	Value	Item Description	Diagram Abbrev.	Values	
					NB-EB	SB-WB *
Road Name		N 1ST ST - WISCONSIN SIDE	Roadway Width	RW	55.0 ft	
LRS Functional Class	26		Vertical Clearance	VC	52.1 ft	
ADT (YEAR)	29 (& 30)	1 (2022)	Max. Vert. Clear	MVC	52.4 ft	
HCA DT	109		Horizontal Clear	HC	115.0 ft	
National Highway System	104	N	Lateral Clr. - Lt	LLC	72.0 ft	
Route Sys/Nbr (LRS)			Lateral Clr. - Rt	RLC	13.0 ft	
LRS Mile Point		NA	Median Width	MW	NA	
Reference Post			* Entered only if this record is for a divided roadway			
Detour Length	19	1 mi.				
Lanes	28B	2 Lanes UNDER Bridge				
Control Section (TH Only)						
Function	5C	MAINLINE				
Type	102	2 WAY TRAF				
Bridge Match ID	5A	5				
Roadway Key		D-UNDER (4TH)

RIGID EDGE IS A TOE OF SLOPE STEEPER THAN 1 TO 3 OR A FIXED OBJECT SUCH AS GUARDRAIL, PIER STRUT OR OTHER BARRIER.

RLC (RIGHT LATERAL CLEARANCE) IS THE MEASUREMENT FROM THE OUTSIDE EDGE OF THE ROADWAY TO THE RIGID EDGE. RIGHT IS DETERMINED WHEN FACING THE DIRECTION OF TRAVEL. RLC IS THE MINIMUM DIMENSION AFTER MEASURING IN BOTH DIRECTIONS.
